Building Condition Assessment and Reserve Fund Study

**Port Nelson United Church
3132 South Drive
Burlington, Ontario**

Byrne Engineering Inc. (Byrne) has performed a Building Condition Assessment (BCA) and Reserve Fund Study (RFS) for Port Nelson United Church (PNUC) located at 3132 South Drive, Burlington, Ontario. This report summarizes the findings and recommendations of the Building Condition Assessment and Reserve Fund Study.

A condition survey of the building and site elements was conducted on May 3, 2010 in order to determine their present condition and estimate their remaining life expectancy. This survey included architectural, structural, mechanical and electrical building systems.

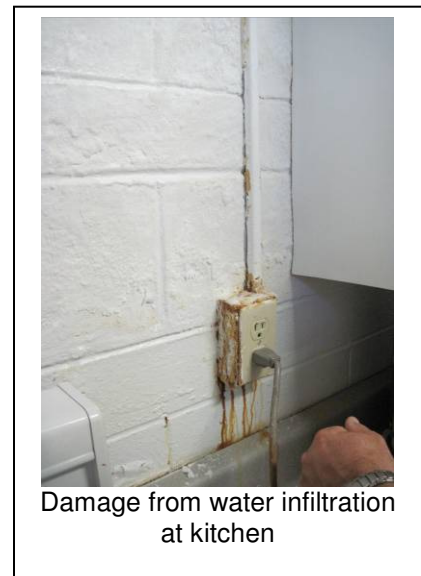
3.1.1 Foundation Walls

Most of the foundation walls are conventional reinforced cast-in-place concrete for all buildings with some interior foundations being 8" concrete block. There were two main areas of water infiltration which are both located in the original church building. One area is quite evident by dried efflorescence on the kitchen masonry wall and rust around an electrical outlet in the south east corner of the building. It appears that the exterior concrete stairs may be the source of water making its way in. These stairs have cracked, delaminated and shifted away from the foundation wall.

The other area of water infiltration is on the west side of the lower Auditorium. It is unclear whether the infiltration is through the wall or the window.

An allowance has been made for further in-depth engineering investigation to determine the source of the water filtration at the window area. It is recommended that the exterior stairs at the south east corner of the building be repaired and all joints with the foundation wall be sealed. As a safety precaution, it is recommended that this electrical outlet be disconnected until the source of the water is determined and the leak stopped.

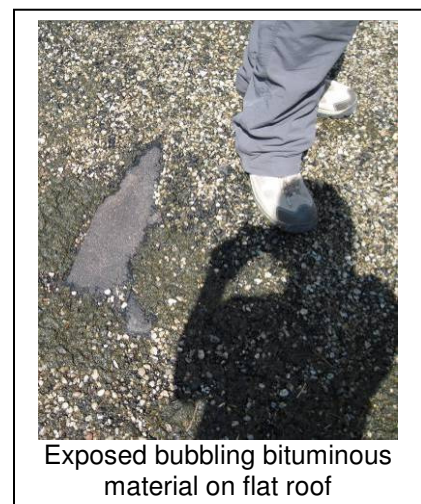
3.2.1 Flat Roof – Central Administration Buildings (Upper and Lower Narthex)

Access to the roof of the Administration Building was obtained via ladder. This was the only flat roof that was accessible. The roof is in poor to fair condition with insufficient slope to roof drains, exposed bubbling bituminous material and moss. It was reported that all flat roofs are original to the construction of the buildings having had only repair work done in recent years. Since life expectancy of built-up roofs is about 20 years and the

newest of the roofs is already 22 years old. It is recommended that all flat roofs be replaced in Year 2.

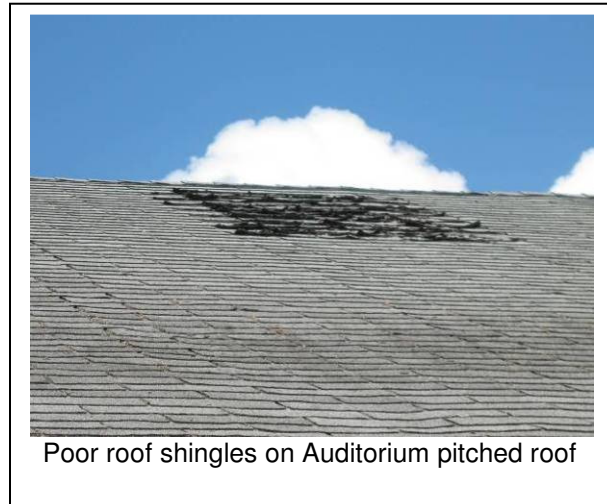
The pitched roofs have been finished with asphalt shingles. The shingles on the Auditorium are in poor condition and members of the committee report that the roof leaks. The effective service life of these shingles has been exceeded. It is recommended that the shingles be replaced in Year 1.

The shingles on the New Sanctuary were replaced in 1999 and appear to be in fair condition. The shingles of the New Sanctuary should be replaced at the end of the expected service life.

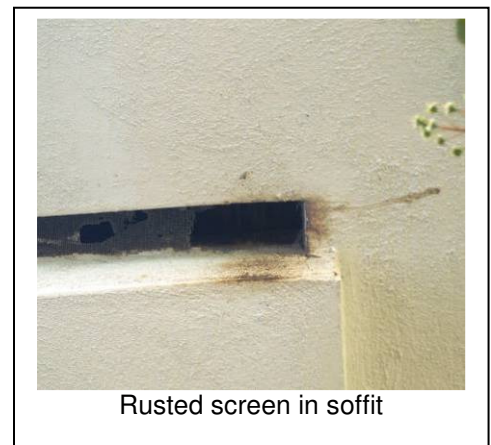
3.2.3 Soffit and Fascia

Soffit and fascia on all roofs, except the new Sanctuary, are a mix of aluminum and painted wood and appear to be in fair to good condition. The soffit and fascia on the new Sanctuary are in poor condition with birds nesting in the damaged screening of the soffit. The soffit and fascia have an expected service life of 40 years. The buildings are at least 50 years old. It is recommended that all soffit and fascia be replaced in Year 1 and 2 with the respective roofs.

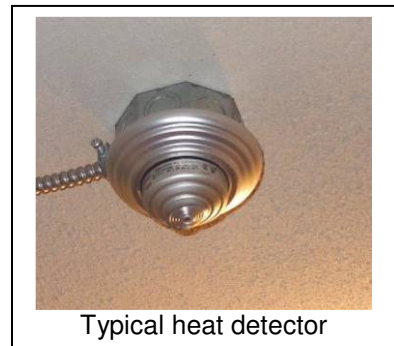
Heat detectors are located in the primary service rooms within the property including the boiler and electrical rooms as well as the kitchens. Heat detectors are hard wired and inspected regularly. They appear to be in good condition and it is recommended that an allowance be allocated to cover the cost of replacement every 10 years.

Typical heat detector

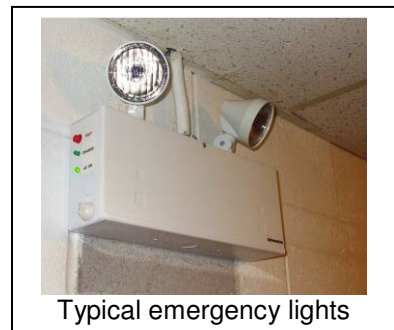
Illuminated emergency exit signs and emergency lighting is located throughout the property. The equipment appears to be in fair to good condition. It was reported that the emergency lights are tested regularly and batteries replaced as required. Lights should be replaced after they are 15 years old. It is recommended that an allowance be maintained for regular replacement of this equipment.

Typical emergency lights

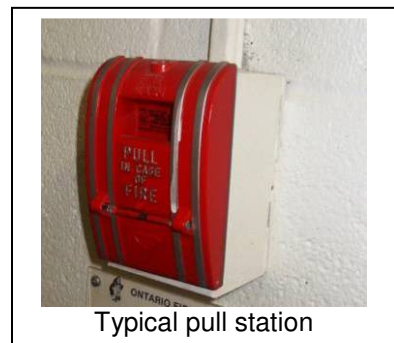
The property is equipped with fire alarm pull stations and bells. The system was upgraded approximately 2 years ago and appeared to be in good condition. It was reported that the system is inspected monthly and monitored by a private monitoring service.

Typical pull station

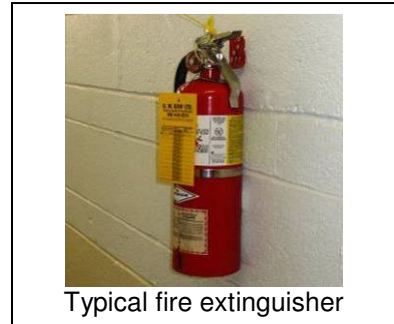
There are fire extinguishers located throughout the property. This equipment has been recently inspected, and appears to be in good condition. An allowance has been allocated to cover the cost of replacing fire extinguishers once they are over 10 years old.

Typical fire extinguisher

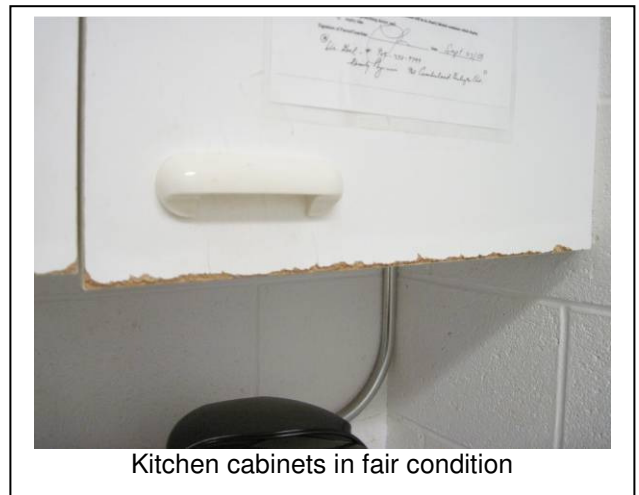
- A. The oak cabinetry, hardware, counter top and stainless steel double sink in the O'Brien Room kitchen is new (within the last 8 years) and is in good condition. This kitchen is expected to last the duration of the study period.
- B. The kitchen in the lower level of the Auditorium has pressboard cabinetry, metal hardware, double stainless steel sink and counter top all circa 1980s. All items are in good condition. It is recommended that this kitchen be upgraded with new cabinetry, hardware, sink and counter

Kitchen cabinets in fair condition

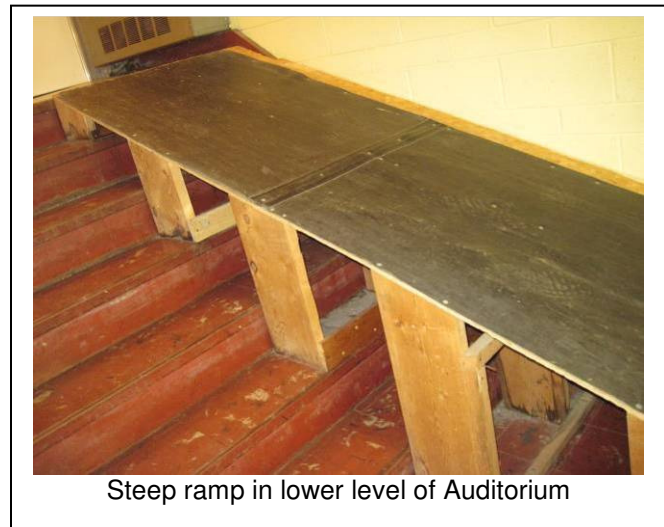
The access ramp, which is located in the Lower Narthex is in good condition and should last the duration of the study. There is a steep ramp located in the lower level of the Auditorium. This ramp is not suitable for wheelchair access and should be removed unless its use is intended as an equipment ramp. If such is the case, it is recommended that a sign be affixed to indicate that the ramp is not intended for wheel chair access. All interior stairs are well maintained and in good condition. Handrails are well affixed and in good condition. Freestanding handrails are expected to last the duration of the study. Wall mounted handrails are a maintenance / operating budget item not considered a capital expense.

Steep ramp in lower level of Auditorium

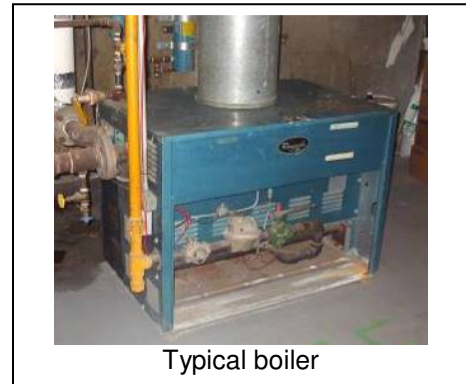
The property is equipped with two boiler rooms. Boiler Room #1 has two 848,000 BTU boilers and Boiler Room #2 has two 685,000BTU boilers. These boilers were replaced in 1979 and 1981 respectively. A Boiler Life Report was conducted in 2004; however this report was not available at the time of this study. Based on the supplied Maintenance History Report, a significant amount of money has been spent on maintenance of the boilers in the last five years including the replacement of the boiler refractories. Although these boilers have exceeded their life expectancy and are not the most efficient equipment, they are very robust. Replacement should be considered and planned for; however budgetary constraints will likely dictate that this equipment update be postponed until absolutely necessary. New high efficiency boilers should contribute towards savings of maintenance and fuel costs. An allowance has been made to replace these boilers in Year 8. Both boiler systems have been fitted with a water filter / treatment system. The filter in Boiler Room #1 appeared to have had a leak, and looked in poor condition. The filter in Boiler Room #2 appeared to be in good condition with no visible signs of leakage. These items would typically be covered in the maintenance budget.

Typical boiler

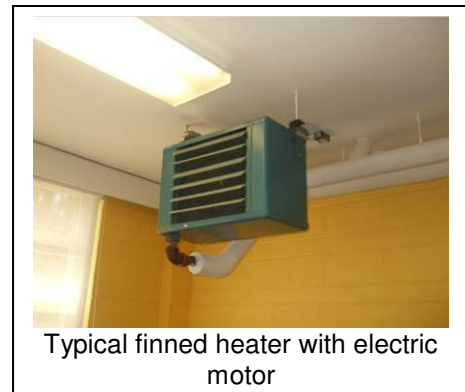
The piping and radiators are all original to the construction of this property. Where visible, the piping appears to be in fair condition. The condition of the radiators varied from fair to poor. The concern with a system as old as this one is that once components start to fail, a cascading effect may happen, and the owner has to be prepared to address a solution in the form of ongoing maintenance or replace the whole system at once. An allowance has been allocated to replace this system in Year 10.

Typical finned heater with electric motor

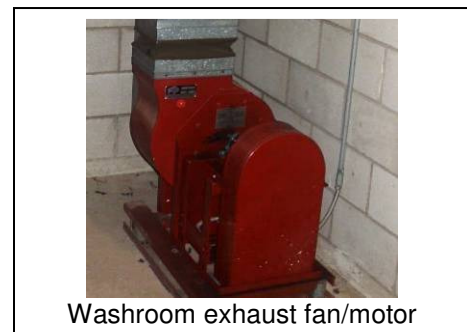
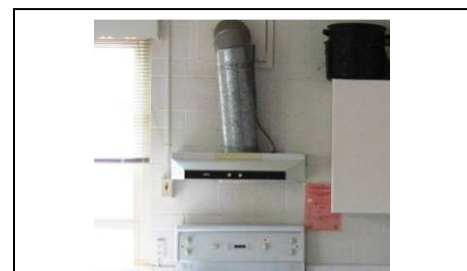
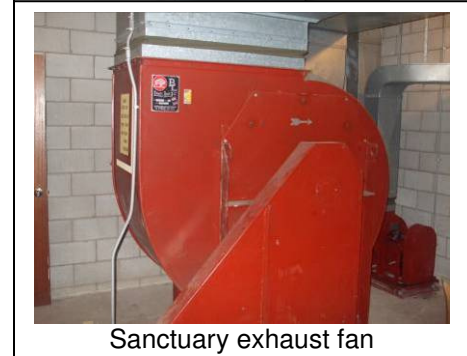
3.6.8 Exhaust Fans - Sanctuary

Air can be exhausted from the New Sanctuary by means of a large evacuation fan located in the basement. This fan is controlled by switches located in the pulpits. Operation of this exhaust fan is manual, and the windows of the Sanctuary must be opened in order to allow for air to flow. This fan and housing is in good condition. The only parts that are likely to require repair or replacement are the motor and bearings. The age of the motor was unknown, however the frame size on the nameplate pre dates 1955. An allowance will be allocated to replace this motor within the next 5 years.

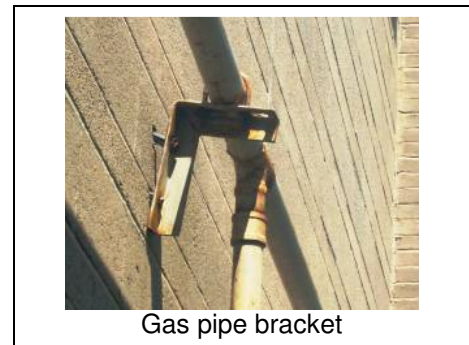
3.6.9 Fuel Distribution

Natural gas is supplied by the local gas utility provider. The meter is at the rear of the building and appears to be in fair condition. The mounting bracket supporting the piping is getting pulled from the concrete block wall. This bracket should be repaired as it could pose a safety threat if it broke from the building and affected the integrity of the gas pipe. As this issue occurs after the meter, this repair is the responsibility of the building owner. It is recommended that a gas pipe fitter be called to service this.

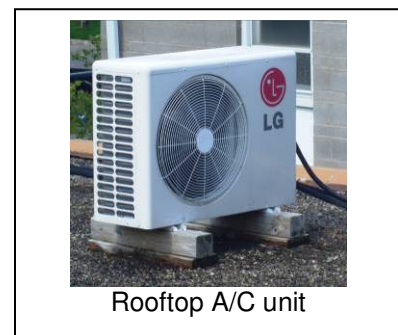
3.6.10 Air Conditioning Units

There is a single roof top air conditioner on the roof of the administration building. This unit serves two offices. The unit appears to be in good condition and is about four to five years old.

There are five window air conditioners. The units varied in condition from good to fair and were reported to be four to five years old. An allowance is allocated to cover the cost of equipment replacement / repair every 3 years.

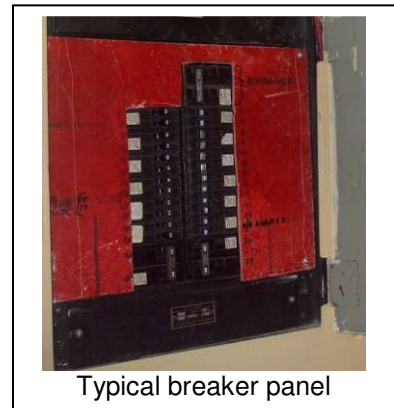
3.8.1 Electrical Panels

The service on site is a 400 Amp 120/240 volt installation. The distribution equipment is original to the construction of the buildings and is in fair condition; however it has reached the end of its expected service life. As indicated in the Electrical Service Report conducted in 2002, the equipment is obsolete and would be difficult to repair if required. As a result, an allowance has been allocated to replace this distribution equipment. The allowance has been allocated to Year 6 of the study, however it may have to be moved up if the electrical load from the building changes significantly.

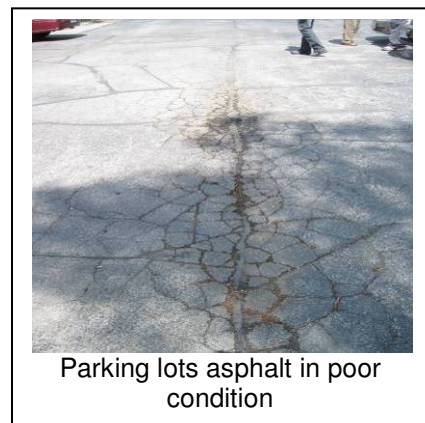
3.9.1 Parking Lots and curbs – Asphalt Paved

The parking lot is located on the south east side of the property. Asphalt is original to the construction of the original church building. Repairs were made in 2002. Asphalt is in poor condition exhibiting many cracks that appear when asphalt is about to break up and create pot holes. It is recommended that the asphalt be completely replaced in Year 5. Concrete curbs are in poor condition with rebar exposed on many units. Concurrently replacing the concrete curbs and asphalt is recommended.

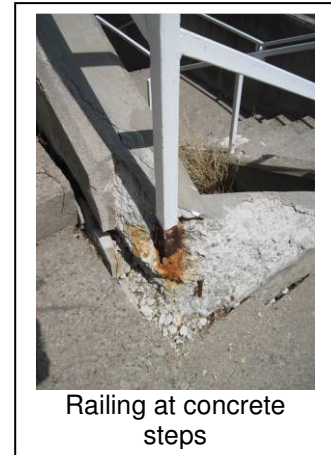
3.9.4 Metal Railing

There are painted metal hand rails at all exterior concrete stairs and ramps providing access to the buildings. The railings are mostly in good condition and all connections are secure except for the handrail located at the south west corner of the Sanctuary. Replacement of this railing is recommended when the handrail curbs are replaced. Refer to section 3.9.9. There is minor paint chipping in some areas. It is recommended that an allowance be made to paint all railings every 10 years. The railings are expected to last the duration of the study period.

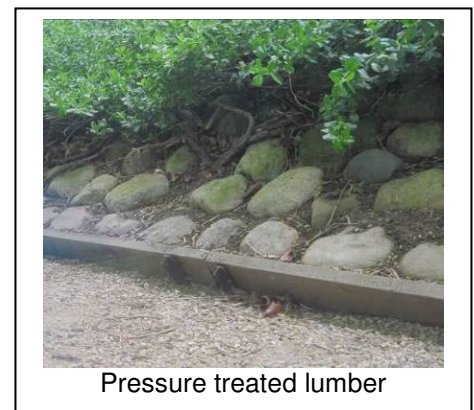
3.9.6 Landscaping – Grading

Slopes are retained on the east and west sides of the Sanctuary by the use of pressure treated milled lumber and landscaping rocks and grass. A 30" wide strip of gravel and drains help to divert water away from the foundation walls and basement windows. There is no evidence of water infiltration at these areas. Replacing pressure treated 2x6 lumber with pressure treated 6x6 timber is recommended as the position of the lumber is being altered over time.

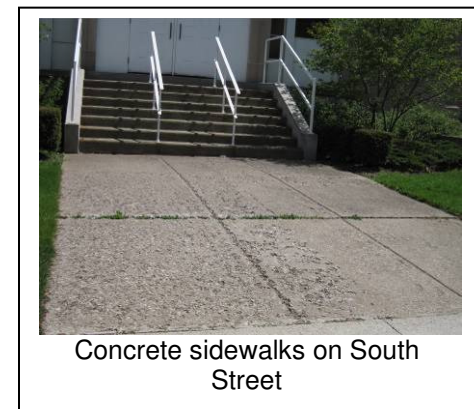
3.9.7 Sidewalks – Concrete

Three concrete sidewalks approach the buildings from the street. The concrete is original to the construction of the buildings and is in poor condition with cracking and breaking down to the aggregate. It is recommended that the sidewalks be replaced with the driveway paving in Year 3.

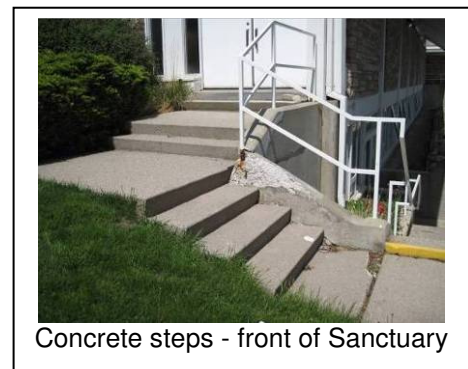
3.9.9 Cast-in-place Concrete Steps

Access to the buildings is provided by four sets of cast in place concrete stair sets and two concrete step pads. The stairs are original to the construction of the buildings and are generally in poor to good condition. Completely replacing the stairs located at the south east corner of the Auditorium in Year 1 is recommended. Repair foundation wall in this area before constructing the new stairs; see Section 3.1.1. Complete replacement of the handrail curb walls on the stair accessing the south west corner of the Sanctuary is recommended. Repair of all remaining stairs and pads in Year 4 is recommended.

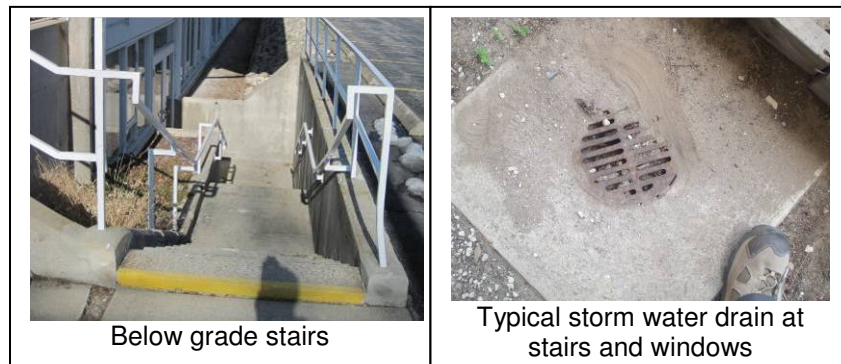
3.9.10 Storm Water Drains

There are main storm water grates in the parking lot. It was reported that these drains have not been cleaned out in quite a while. Storm water from the roofs that drains to the rear of the buildings is directed into the storm water drains. In front of the below-grade windows of the new Sanctuary is an area equipped with storm water drains. These drains as well as the drains at the bottom of the below grade concrete stair wells are completely filled with sand and silt. It is recommended that all the storm water drains be professionally serviced and cleaned with an allowance for regular maintenance.
